Journeys: Explore Your Local Area

While buildings that are pristine examples of a period or architectural style are beautiful and interesting, the CBA enjoy buildings with features that show a journey through time.

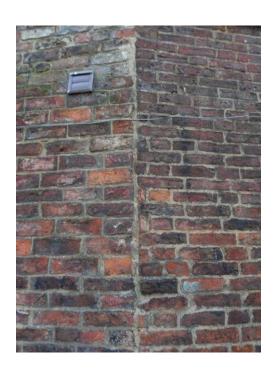
Different brick types:

<u>Smaller</u> bricks tend to be older as a brick tax introduced in 1784 meant bigger bricks were cheaper to build with.

A clear line between bricks (where they aren't tied into the rest of the building) shows a later addition.

<u>Colour</u> can be an indicator of changes – with contrasting brick types or newer ones that haven't yet been as weathered.

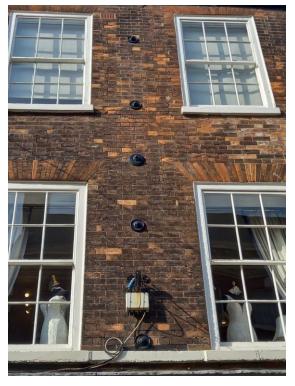
Cross piece of tie beams:

This cross or stud on an exterior wall is connected to a timber beam. They indicate it is a timber framed building – even if it is now hidden behind brick.

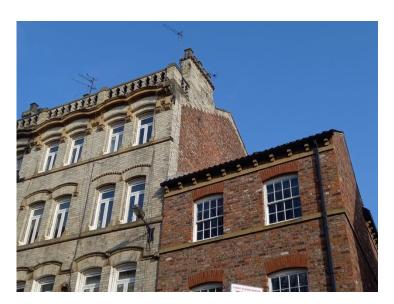
Refronted building:

Where a whole new front is added to a building to change its architectural style. This can be seen in a line in the bricks or where the new front goes above the original roof line.

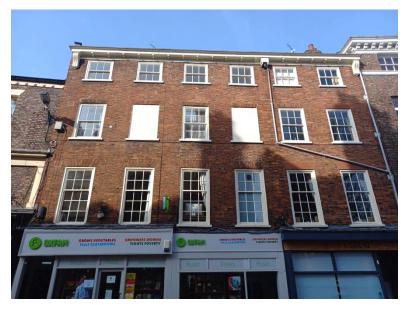
Former windows:

Can be seen in a rectangle of new bricks or where an old lintel remains. Often due to a change in the original interior layout of a building.
